**Technical Report 1628**  
September 1993

# **Dynamic and Static Exposure Tests and Evaluations of Alternative Copper-Based Antifoulant Coatings**

E. Lindner

**NAVAL COMMAND, CONTROL AND  
OCEAN SURVEILLANCE CENTER  
RDT&E DIVISION  
San Diego, California 92152-5001**

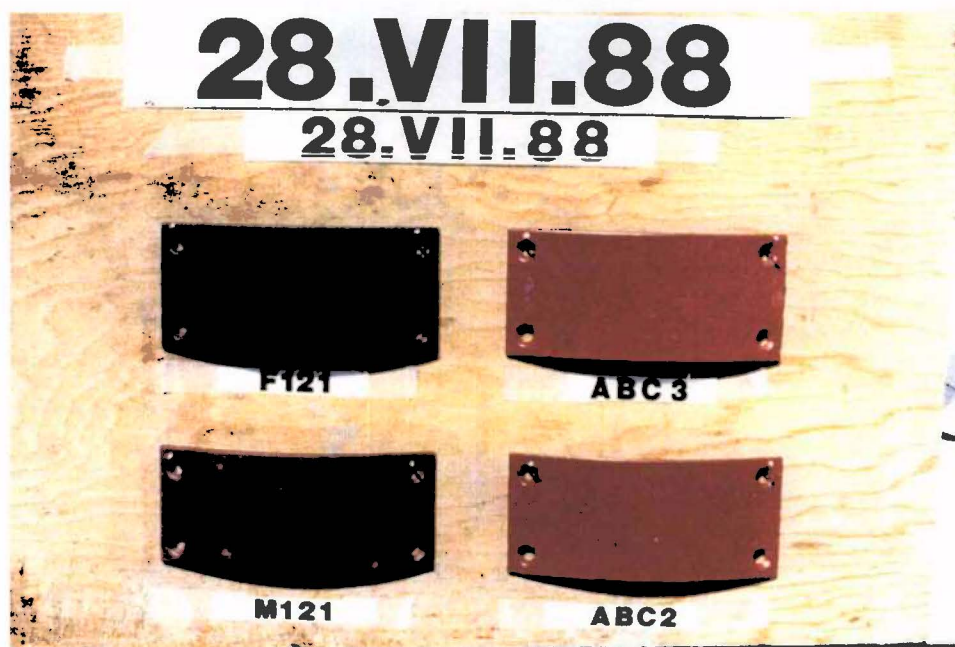
Figure 4. F121, M121 (modified F121), ABC3, and ABC2 before exposure.

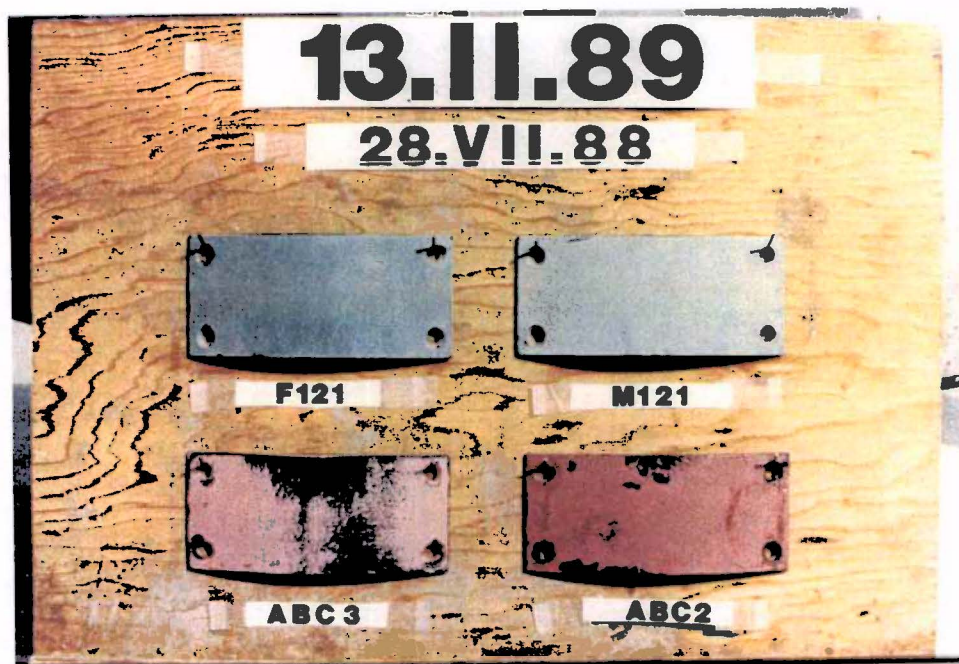
The ABC3 is essentially the ABC2 organotin/ $\text{Cu}_2\text{O}$ -based ablative coating formula without the organotin component. ABC3 showed the fastest erosion among the tested paint systems in the dynamic/static exposure (graphs B-16 and B-17 in the appendix). Erosion could already be detected after only 6 months (figures 4 through 9) and complete loss of the AF layer appeared after only 15 months of exposure. Most of the AF was lost by the end of the second year (figures 8 and 9). The remaining AF paint showed reasonable protection against fouling. The leaching rate was strongly affected by the dynamic/static cycles, and it remained relatively high (avg  $30 \mu\text{g-Cu}/\text{cm}^2/\text{day}$ ). Apparently, ABC3 (and ABC2) are relatively soft formulations that cannot withstand high currents. Because of paint deterioration, the dynamic/static exposure of ABC3 was discontinued after 32 months.

Figure 6. After 6 months of dynamic/static exposure, ABC3 and ABC2 show erosion.

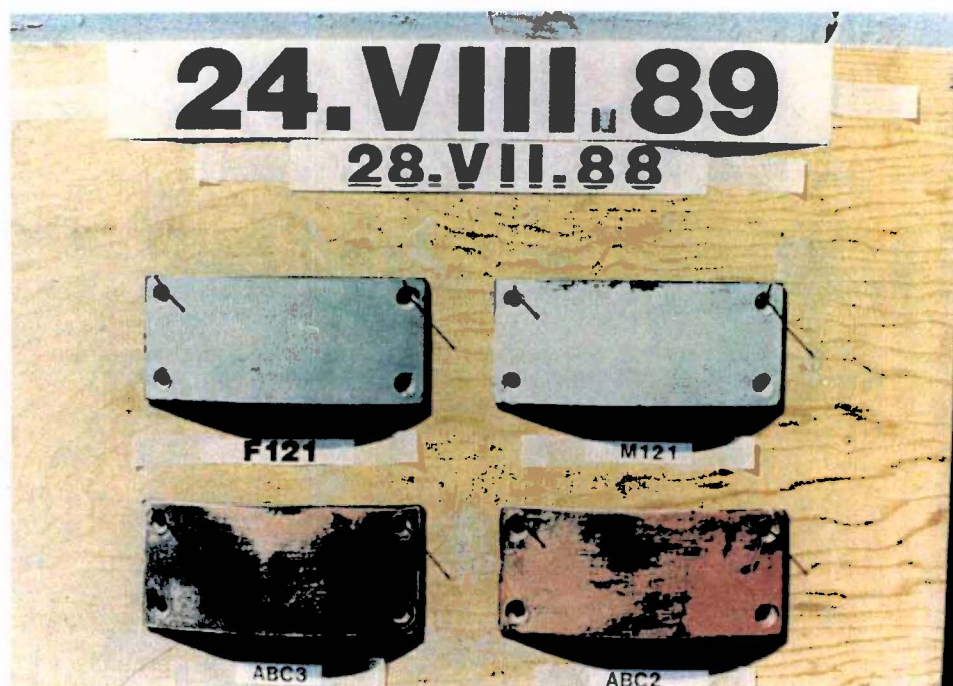
Figure 7. After 1 year of dynamic/static exposure, ABC3 completely lost one layer (red) of AF coating. ABC2 shows similar erosion. Loss of green AF coating appeared on the middle of the edge of M121.

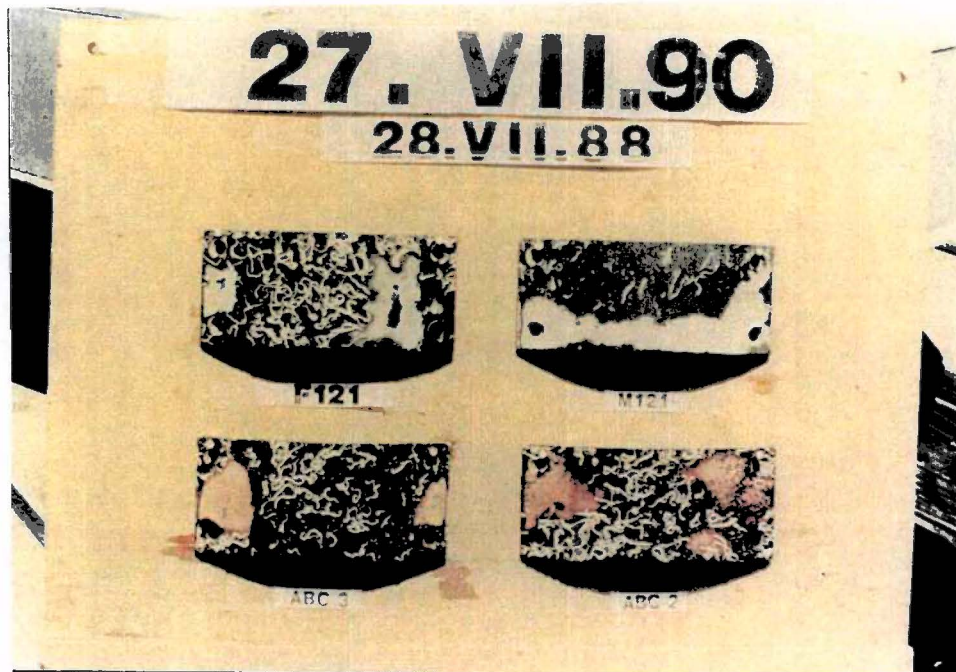
The F121 AF coating began eroding after 18 months of dynamic/static cycle exposure. Those panels, which were subjected to photography, leaching rate, and other test interruptions involving the drying of the AF surface, almost completely lost their AF coating within 27 months (graphs B-6 and B-7). To continue the exposure tests in July 1991, these panels were replaced with backup panels that had undergone the same dynamic/static cycle, but were not tested. The backup panels that had never been dried still had about 50% of their AF coating.

Figure 8. After 2 years of dynamic/static exposure, ABC3 and ABC2 lost almost all of their AF coating. Most of F121 and M121 were also eroded. The bare areas accumulated fouling (tube-worms) during the static cycle.

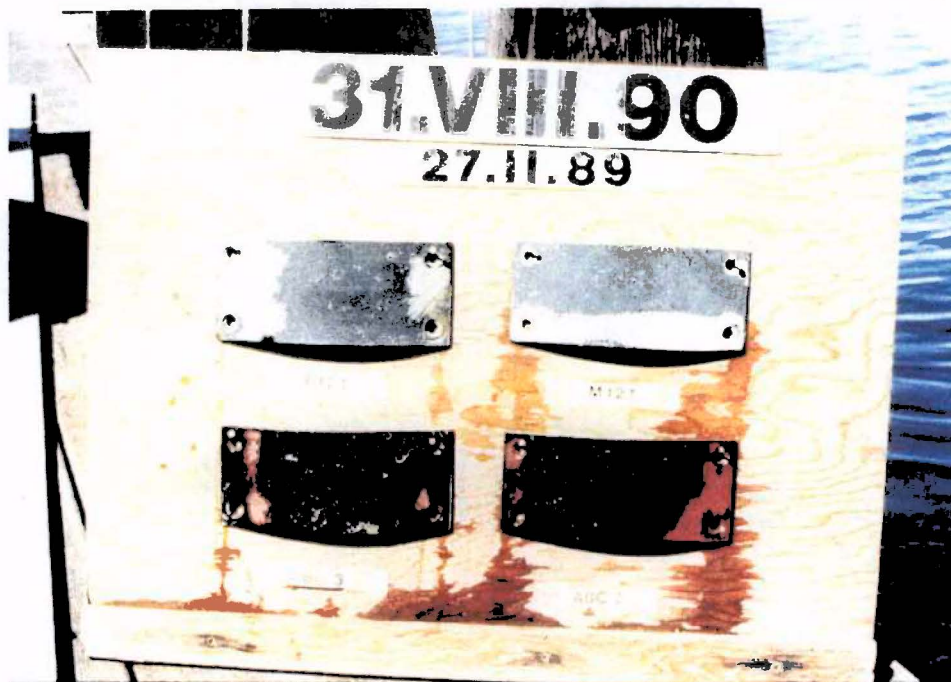
Figure 9. The fouling was removed by the currents during the dynamic cycle, and the black areas that are without AF coating are clearly visible.

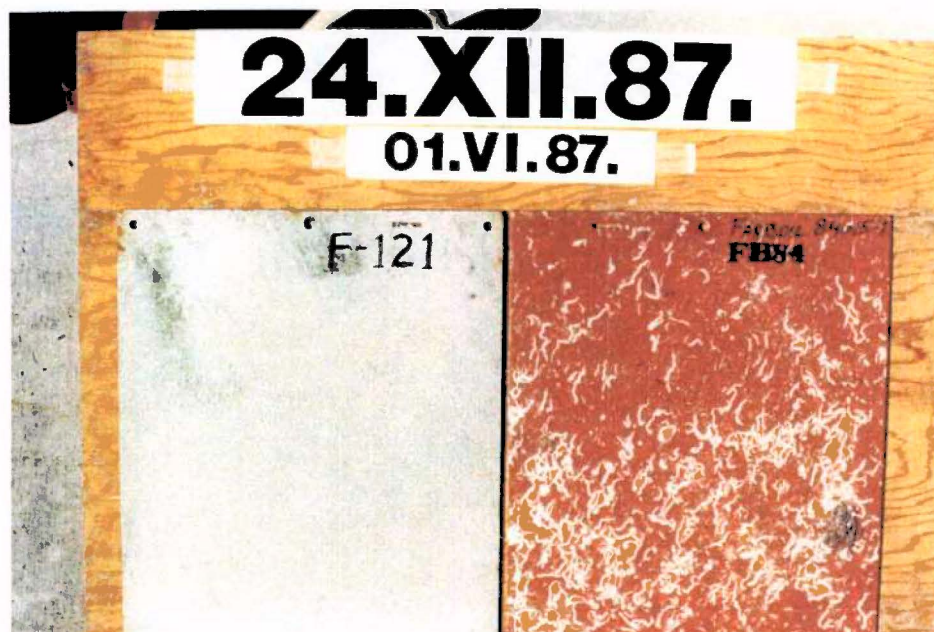
The FB84 retained its paint integrity better than any other paint system in this series. It also remained bright red during the entire test. The leaching rate, however, plunged below the critical  $10 \mu\text{g-Cu}/\text{cm}^2/\text{day}$  level within 30 days, and the paint accumulated heavy fouling within 2 months (graph B-45 and figure 14).

Figure 14. Farboil 844015-1 remained red, but accumulated heavy tubeworm growth within 6 months of static exposure.

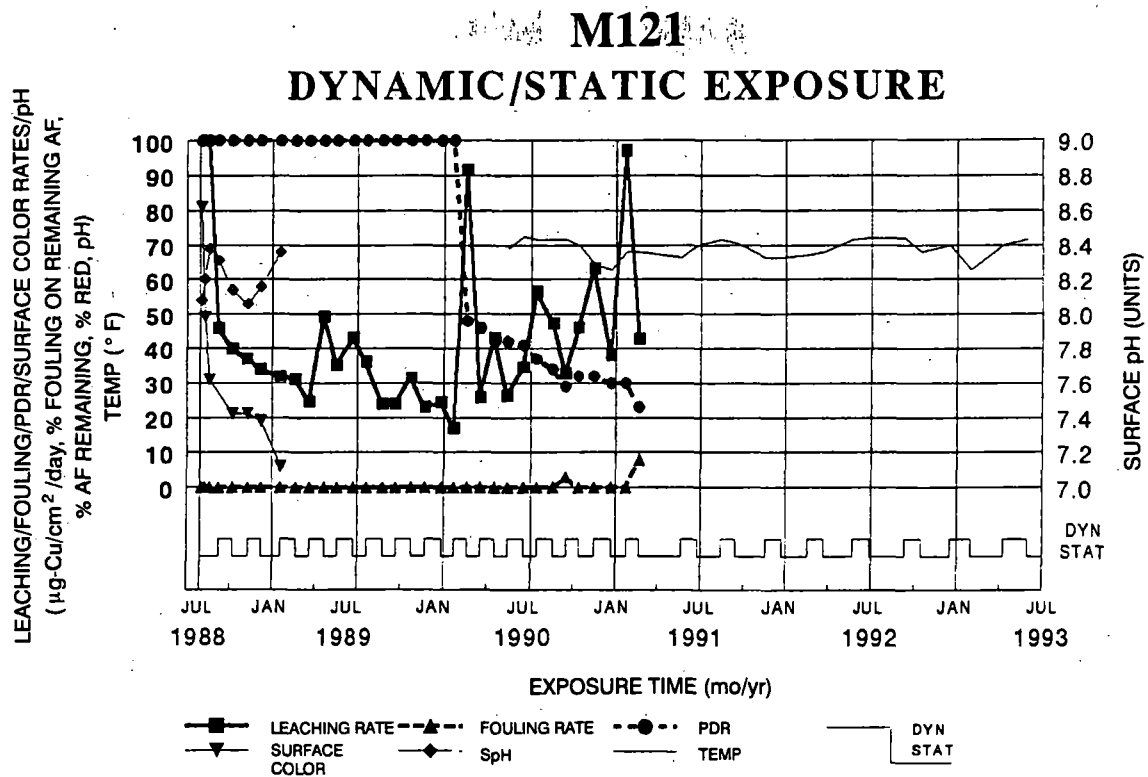
**Graph B-12. Dynamic/static exposure tests for M121 from July 1988 to July 1993.**

The M121 paint is basically an F121 formula modified by addition of 0.5%  $(\text{NH}_4)_2\text{SO}_4$  to increase the acidity (lower the pH) of the paint matrix and to prevent the formation of the green layer. The AF layer eroded quickly after 18 months dynamic/static exposure (graphs B-12 and B-13 in the appendix). The leaching rates of M121 and F121 were essentially identical. Similarly, the color changes of the original and the modified formula were identical as shown in figures 4 through 6 (and graph B-14 of the appendix). The surface pH of the 0.5%  $(\text{NH}_4)_2\text{SO}_4$  modified formula was somewhat lower than that of the unmodified F121 (graph B-15 in the appendix), but no significant benefit from the 0.5%  $(\text{NH}_4)_2\text{SO}_4$  addition was found. The exposure of the modified formula was discontinued after 32 months.

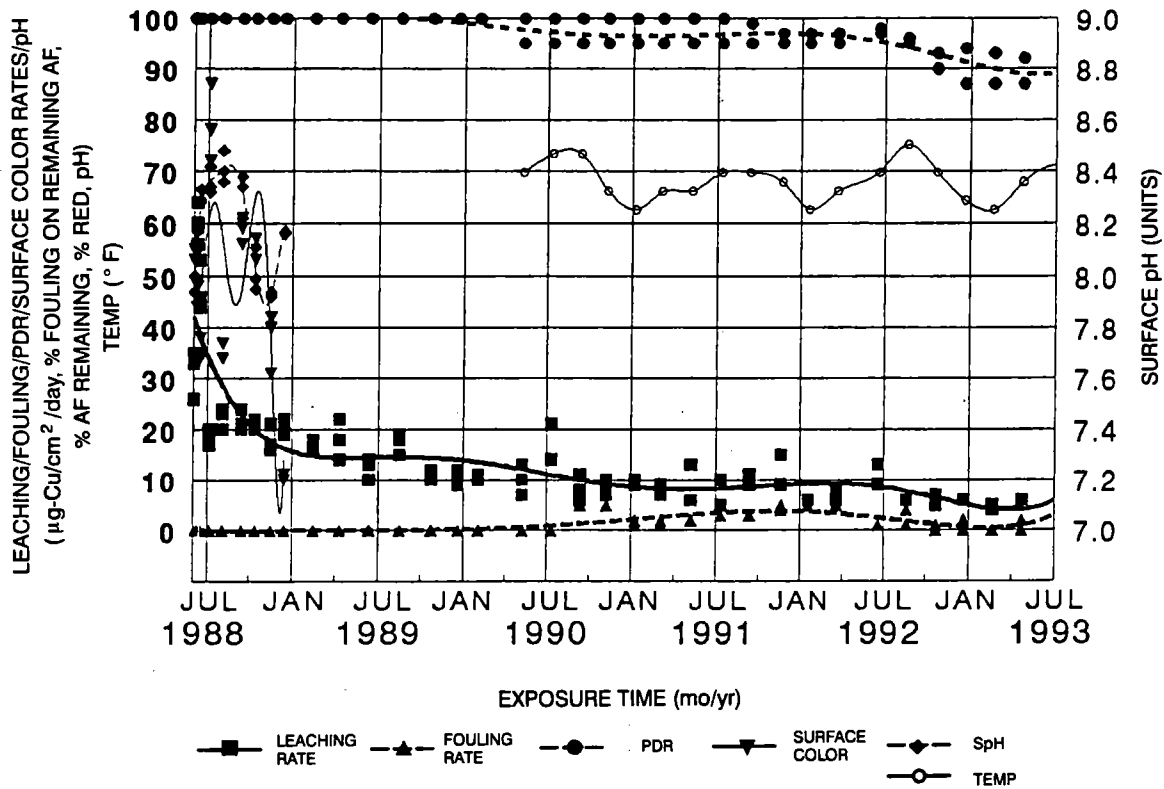
**Graph B-18. Static exposure tests for ABC3 from July 1988 to July 1993.**

Some deterioration of ABC3 was observed during static exposure, as well (graphs B-18 through B-19 in the appendix). In an earlier experiment, ABC3 started peeling off after only 6 months static exposure (graphs B-20 and B-21 in the appendix). The leaching rate of ABC3 in the static exposure was equivalent, or somewhat higher than that of F121. Also, it had slightly better AF efficiency than F121. The color of ABC3 varied throughout the 5-year exposure. By the end of the 6-month monitoring period, it had turned green (graph B-22 in the appendix). Later, it recovered its red and showed several cycles between red and green during the 5-year exposure. There was no significant difference between ABC3 and F121 in surface pH.
